ProTECT68 PRESSURE CONTROL KIT

1030362 2007-2018 68RFE Transmission

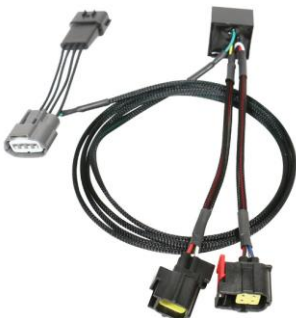
Kit Contents for 1030362		
1030369	4799778	1600186

68 RFE Pressure Controller	Clutch Feed Seal	Gasketed; Separator Plate
Qty: 1	Qty: 3	Qty: 1

Gasket	Check Ball	Accumulator Plate
Qty: 1	Qty: 2	Qty: 1

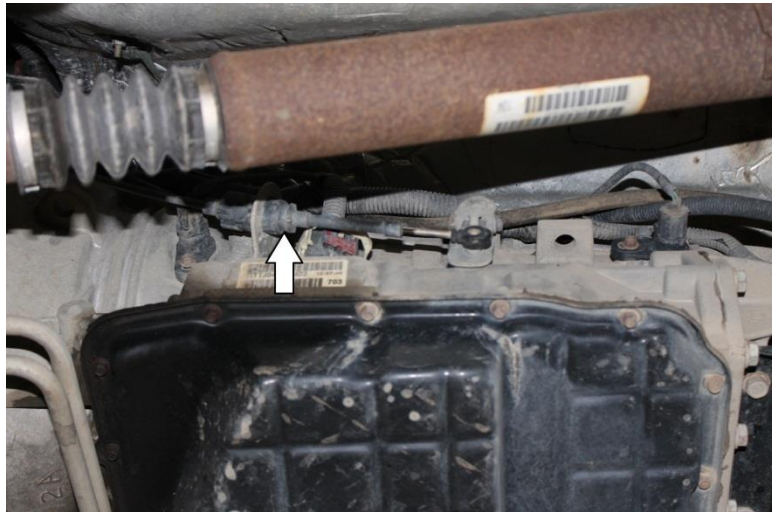
6. To remove connector, push red tab (1) downwards. Then, press the black tab (2) which will allow the white handle (3) to be rotated downwards, releasing the connector from the transmission.

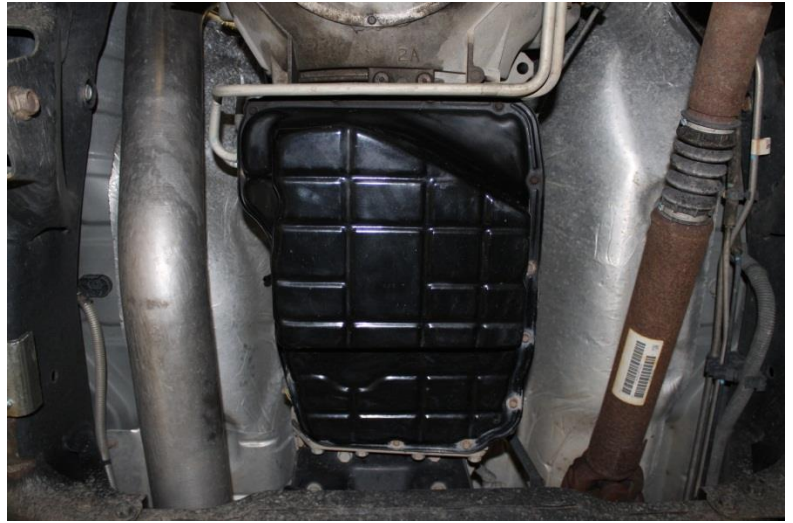
8. Remove 14 of the 15 transmission pan bolts (8mm). Loosen the remaining bolt but leave in place to keep the pan from falling. The transmission cooler lines may need to be moved to access some of the bolts, gently pry them out of the way.

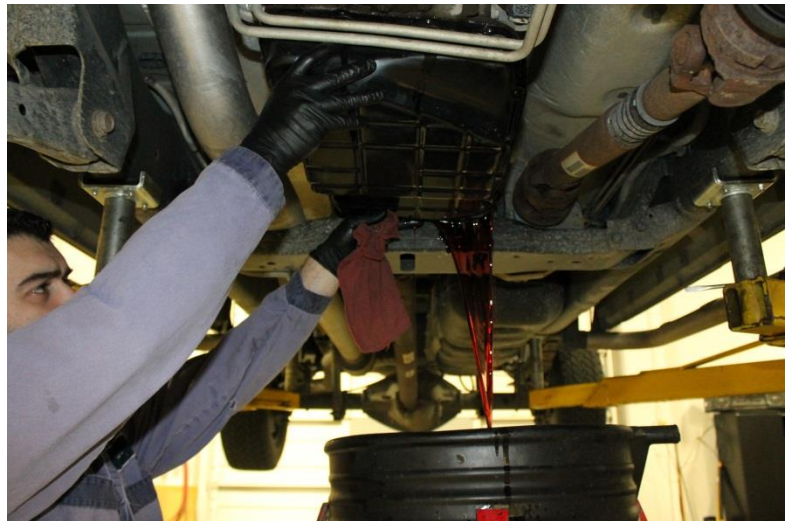
9. Tap pan with a mallet to break the silicone gasket seal. Allow fluid to drain. Remove last screw and drain remainder of fluid.

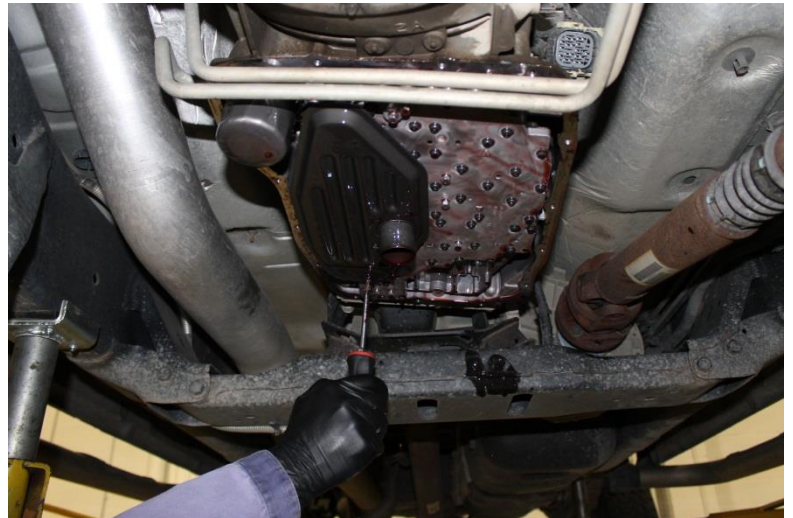
10. Remove transmission filter by removing the one T25 Torx screw.

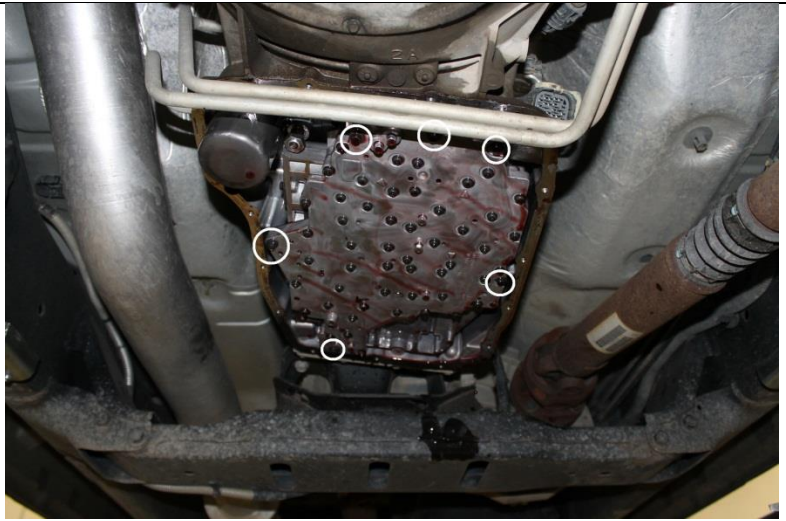
11. Remove the six 8mm bolts securing the valve body to the transmission. Drain valve body of fluid. To remove valve body from transmission, wiggle it while pulling downwards to work the electrical connector through the case.

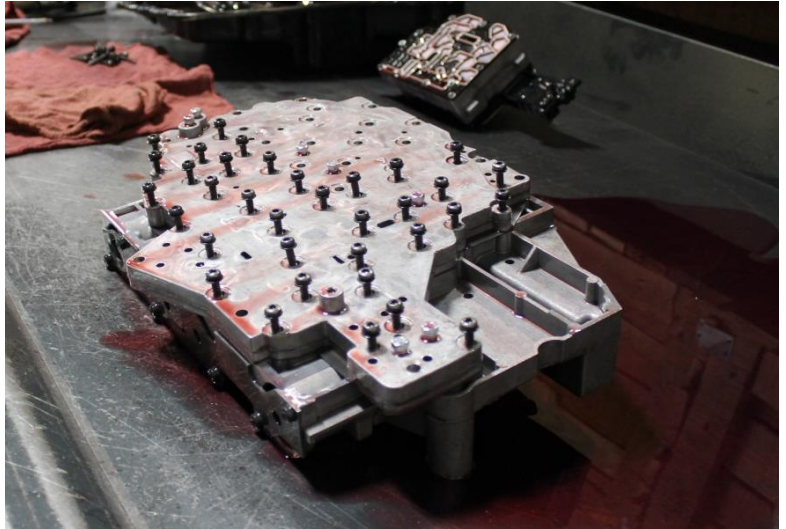
14. Remove remaining thirty five T25 Torx screws securing the valve body halves.

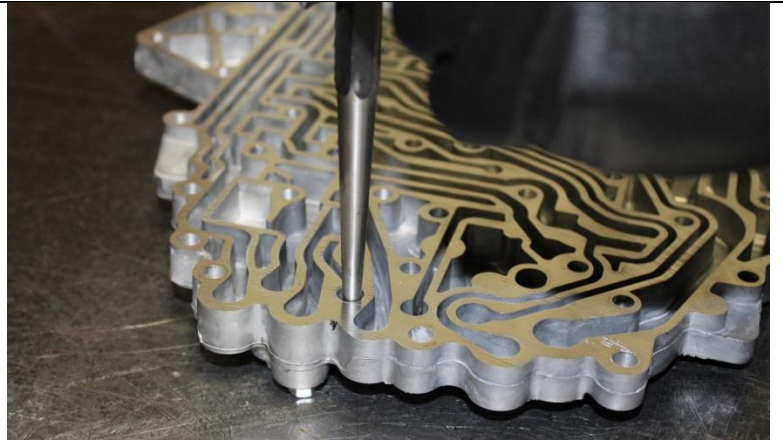
18. Punch center of hole using a center punch.

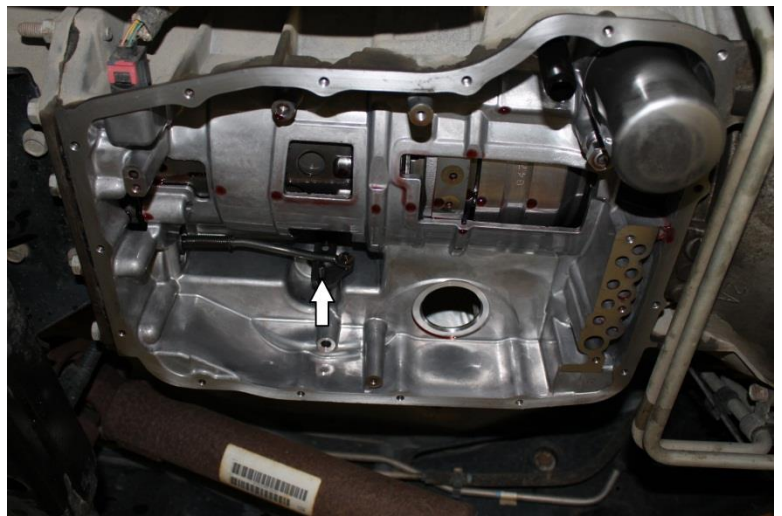
30. Check that the shift lever on the valve body lines up with the shift lever on the transmission and lift the valve body back into the transmission. Start the 8mm screws by hand, do not tighten yet. Work the shift lever on the outside of the transmission case by hand to ensure that the lever is making contact with the valve body correctly.

IMPORTANT: Use great care when reinstalling the valve body, the gasket that mates with the front of the case must line up correctly. Do not fold or pinch during installation.

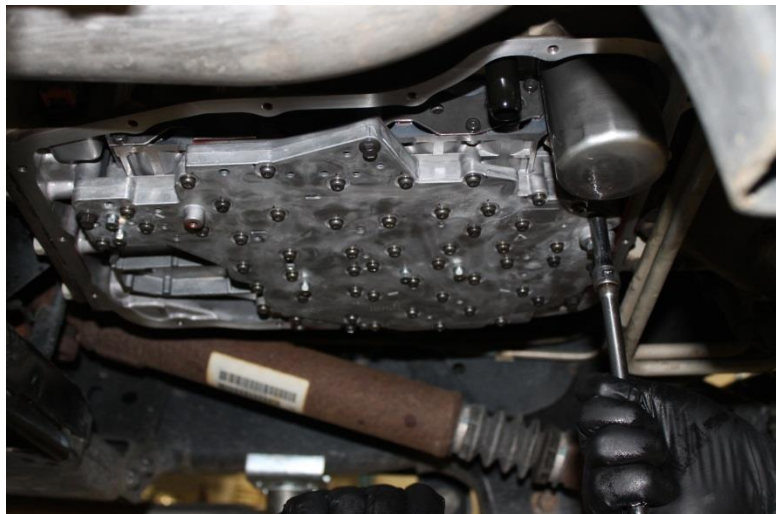
31. Torque the valve body attaching bolts to 105 in/lbs.

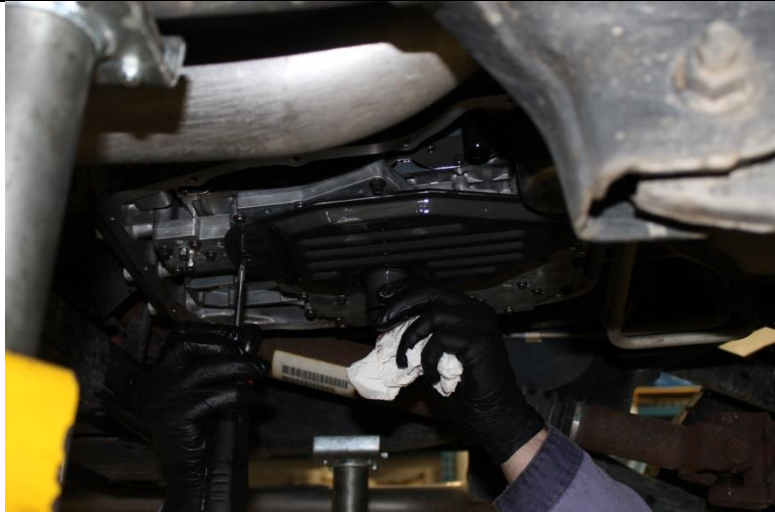
<p>32. If desired, install new filter(s). Otherwise, reinstall the filter/pickup assembly. Torque to 50 in/lbs.</p>

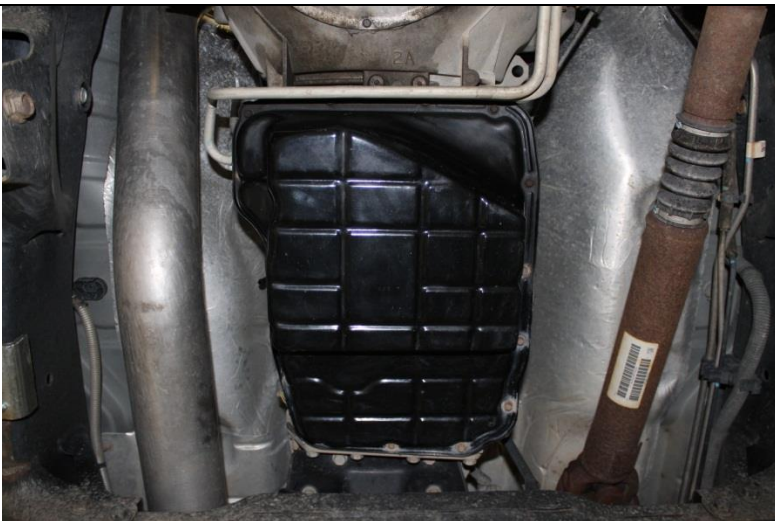
<p>33. Place the supplied gasket on the transmission pan. Hold pan below transmission and install attaching screws. Torque the pan screws to 105 in/lbs.</p>

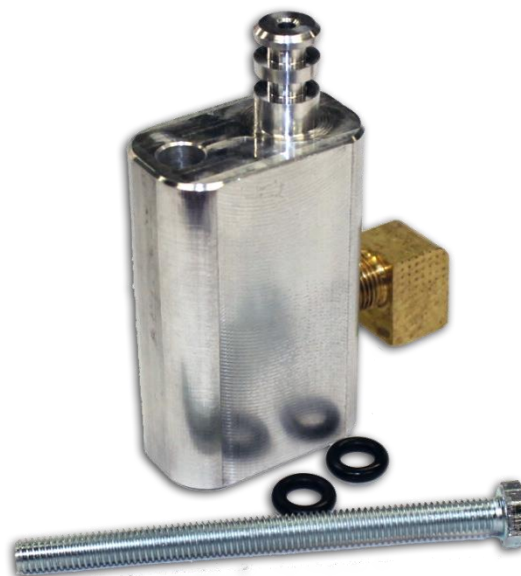
ADAPTER KIT BD# 1061529

40. Note. If you would like to verify the increases in line pressure, use adapter kit (BD 1061529) in conjunction with a 300psi gauge. Pressures at wide open throttle should be between 240 – 260 PSI with a mechanical gauge.

Use this kit with a 300 psi gauge.
