XDP 6.0L Upgraded Exhaust Up-Pipe Assembly
Item Number: XD218

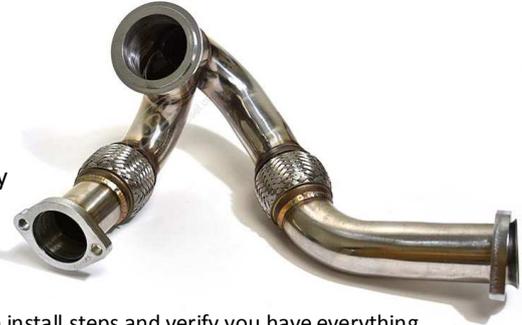
- 1 – XDP 6.0L Upgraded Exhaust Up-Pipe Assembly
