## PART NO. XD375

## XDP ALUMINUM COOLANT RECOVERY TANK RESERVOIR

**INSTALLATION MANUAL**

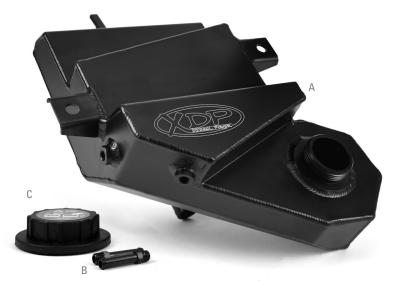
CODE	DESCRIPTION	QTY
Α	XDP Aluminum Coolant Recovery Tank Reservoir	1
В	1/4" NPT to 3/8 Barb fitting	2
С	Degas Cap	1
